# **ISS Fiber Optic Failure Investigation**

## **Root Cause Report**

**August 1, 2000**

**ISS Fiber Root Cause Investigation Team  
Lead organization NASA GSFC  
Sponsored by: NASA JSC and the Boeing Company**

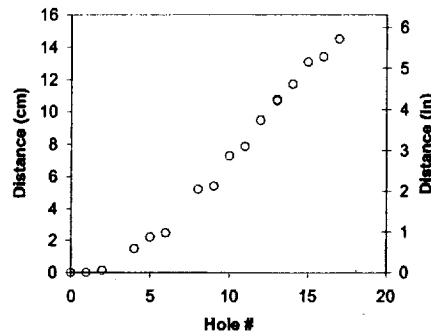
**Figure 14** Distribution of Features Along a 6" Sample of CD0588XD Fiber

The arrangement of the bubbles and depressions were found to be in a fairly straight line and parallel with the longitudinal axis of the fiber. Figure 14 is a plot of the distribution of the features along the length of one of the "588" samples.

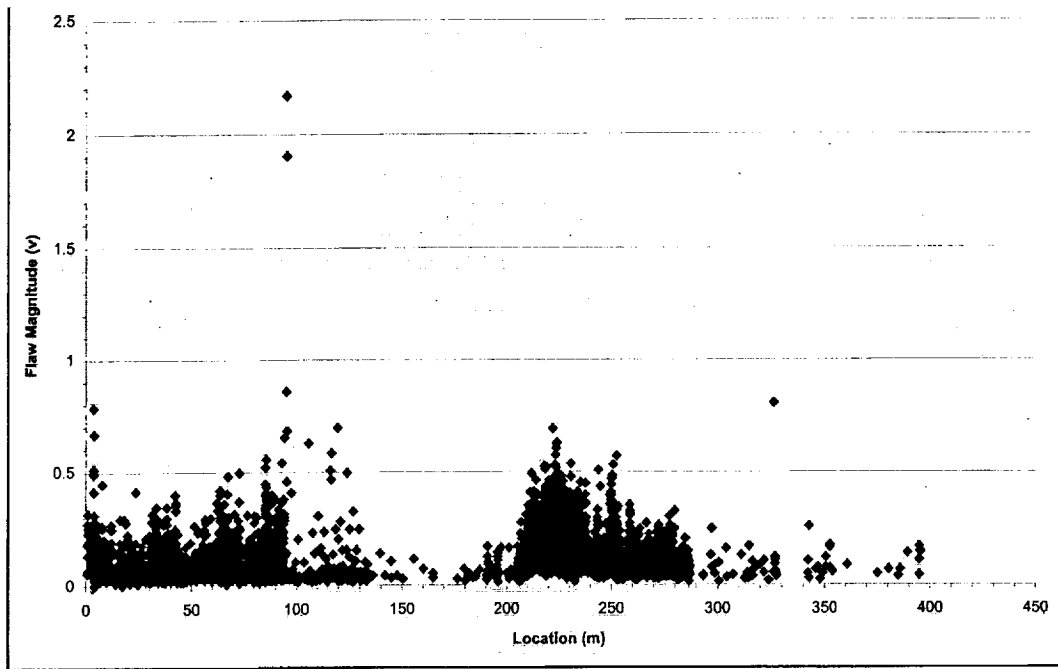
**Figure 19 Feature Statistics for CD0588XD**

To see if, using a more typical inspections speed, 0.5 m/sec, the machine could provide useful statistics which would differentiate the two reels. Figure 19 and Figure 20 show the results of running approximately 400 m through the machine, looking for a 0.1V feature size or greater. Additional work is required to understand the usefulness of a system such as this to identify defects in the polyimide coating.

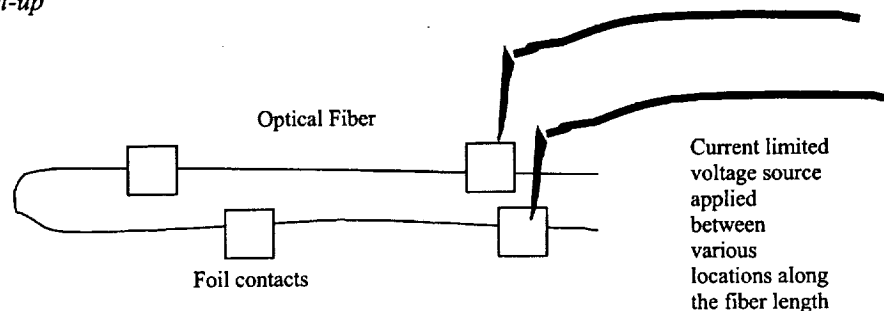
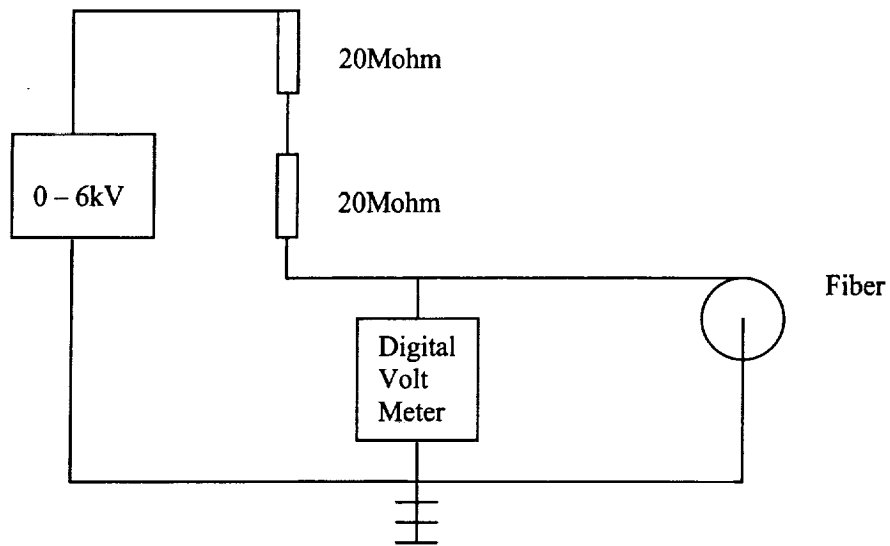
**Figure 27** Experimentally Produced ESD Damage

The Aerospace Corporation used the set-up shown in Figure 27b with an associated burn mark shown in Figure 22. The Aerospace Corporation found abrupt breakdown at 3.9kV in a 50% relative humidity environment, indicating a 6.5 kV/mil dielectric strength. Burn marks were found with a variety of sizes the smallest being 30  $\mu$ m in diameter. They also measured the resistance of the carbon coating for lengths between 1 and 34 cm to be approximately 15 kOhm/cm, which agrees with Lucent-SFT’s databook value.

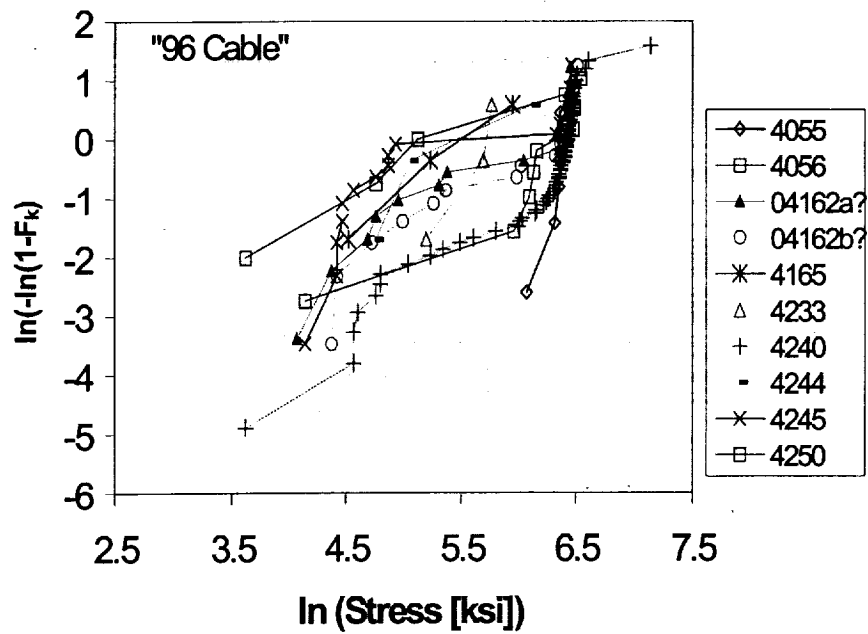
Figure 31 Strength Data for 1996 Cable by Strain Rate

The results of the initial strength tests are shown in the Weibull plots in Figures 30 and 31. Prior analysis showed that the fiber shipped by Lucent-SFT was proof tested to 141 kpsi (@ 3.36 lbs). The cable specification requirement is for a fiber strength of 200 kpsi (@ 4.76 lbs). Lindholm, et. al., report strengths of 500 kpsi (11.90 lbs) and higher for four carbon coated fibers they have manufactured. The plots showed the high strength of the cabled fiber to be around 252 kpsi (6 lbs) and the low strength to go as low as 126 kpsi (3 lbs).

The inspections found that defects were present in large numbers that were either small etch pits at the surface of the cladding or corrosion sites in the same location. The knees in the Weibull plots, an associated slopes, show that there is more than one dominant failure mode. According to the physics of glass, the order of the curves should show the black circles (highest strain rate) located to the right of the other curves, not to the left. Figure 31 shows that the distribution of low strength breaks among the reels was significantly different even for reels with the same date of manufacture. These distributions could not be used to quantify the expected life of the cable using classical methods.

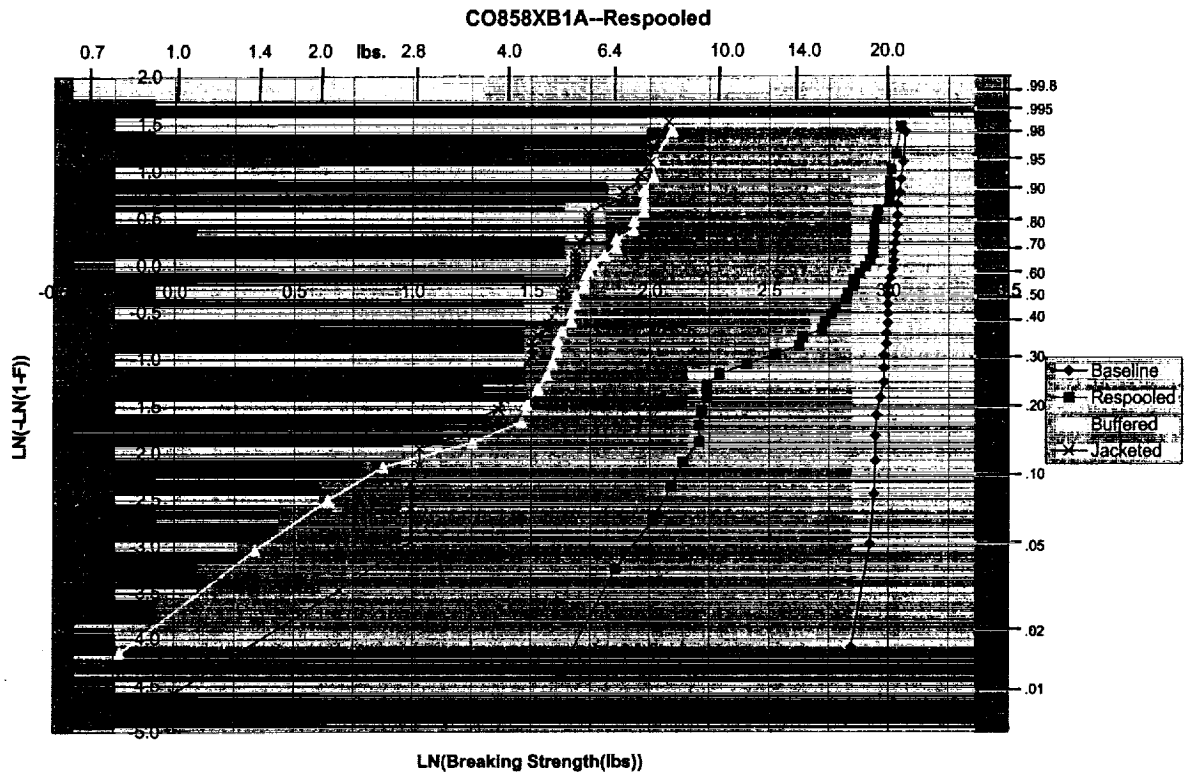
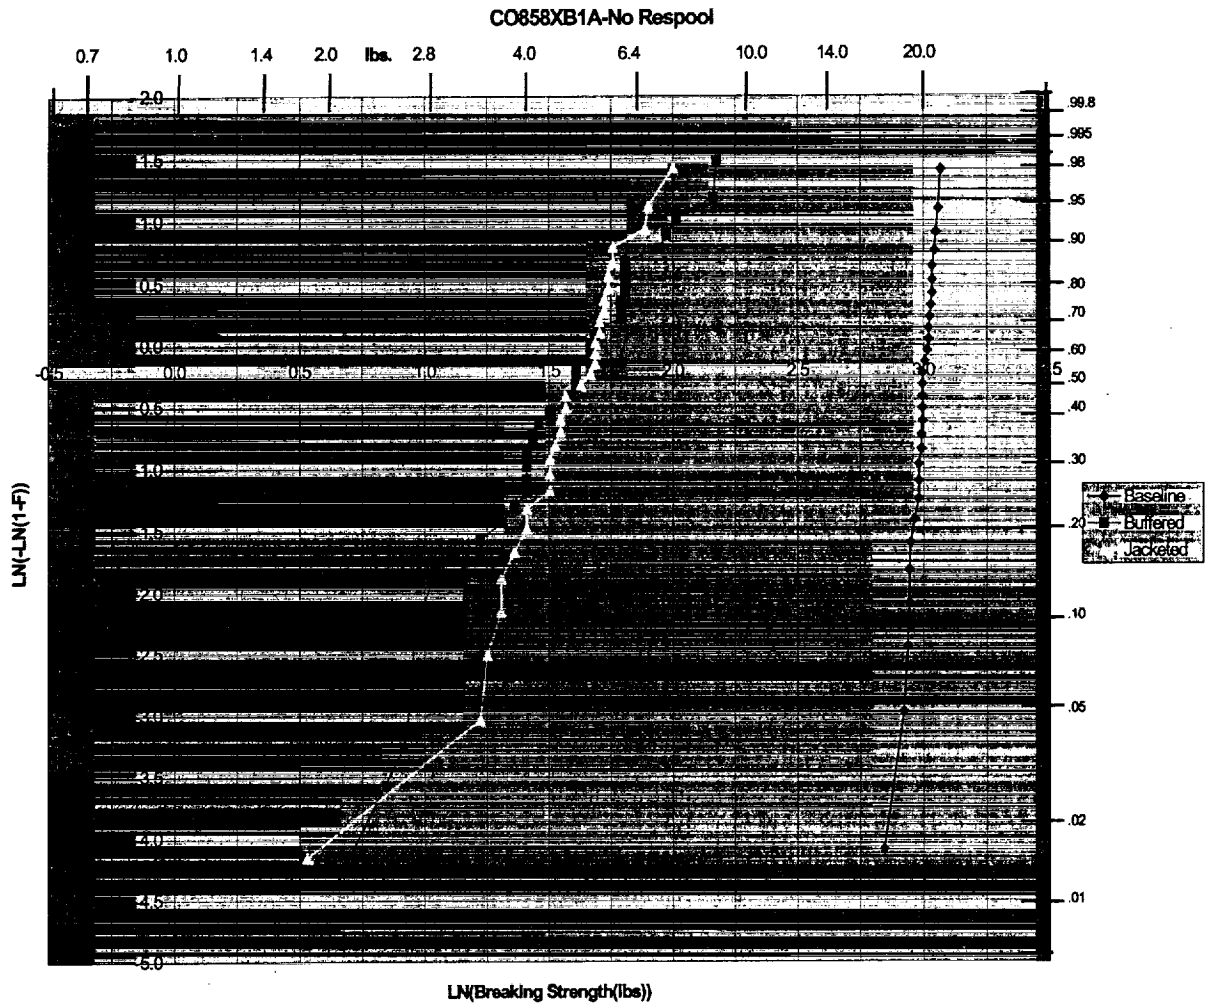
**Figures 35 Strength for the Non-carbon Coated Fibers**

Figure 35a through 35c show the affect of the various cabling processes on the fiber strength for the non-carbon-coated fibers. The unprocessed fiber has high strength, however as it goes through cabling, its strength is again increasingly reduced. The difference in the behavior between the two non-carbon coated fiber lots is still under study. [ref-26]
